DELAWARE RIVER BASIN
HAYNES CREEK TRIBUTARY
BURLINGTON COUNTY
NEW JERSEY

CENTENNIAL LAKE DAM

NJ 00424

PHASE 1 INSPECTION REPORT NATIONAL DAM SAFETY PROGRAM.

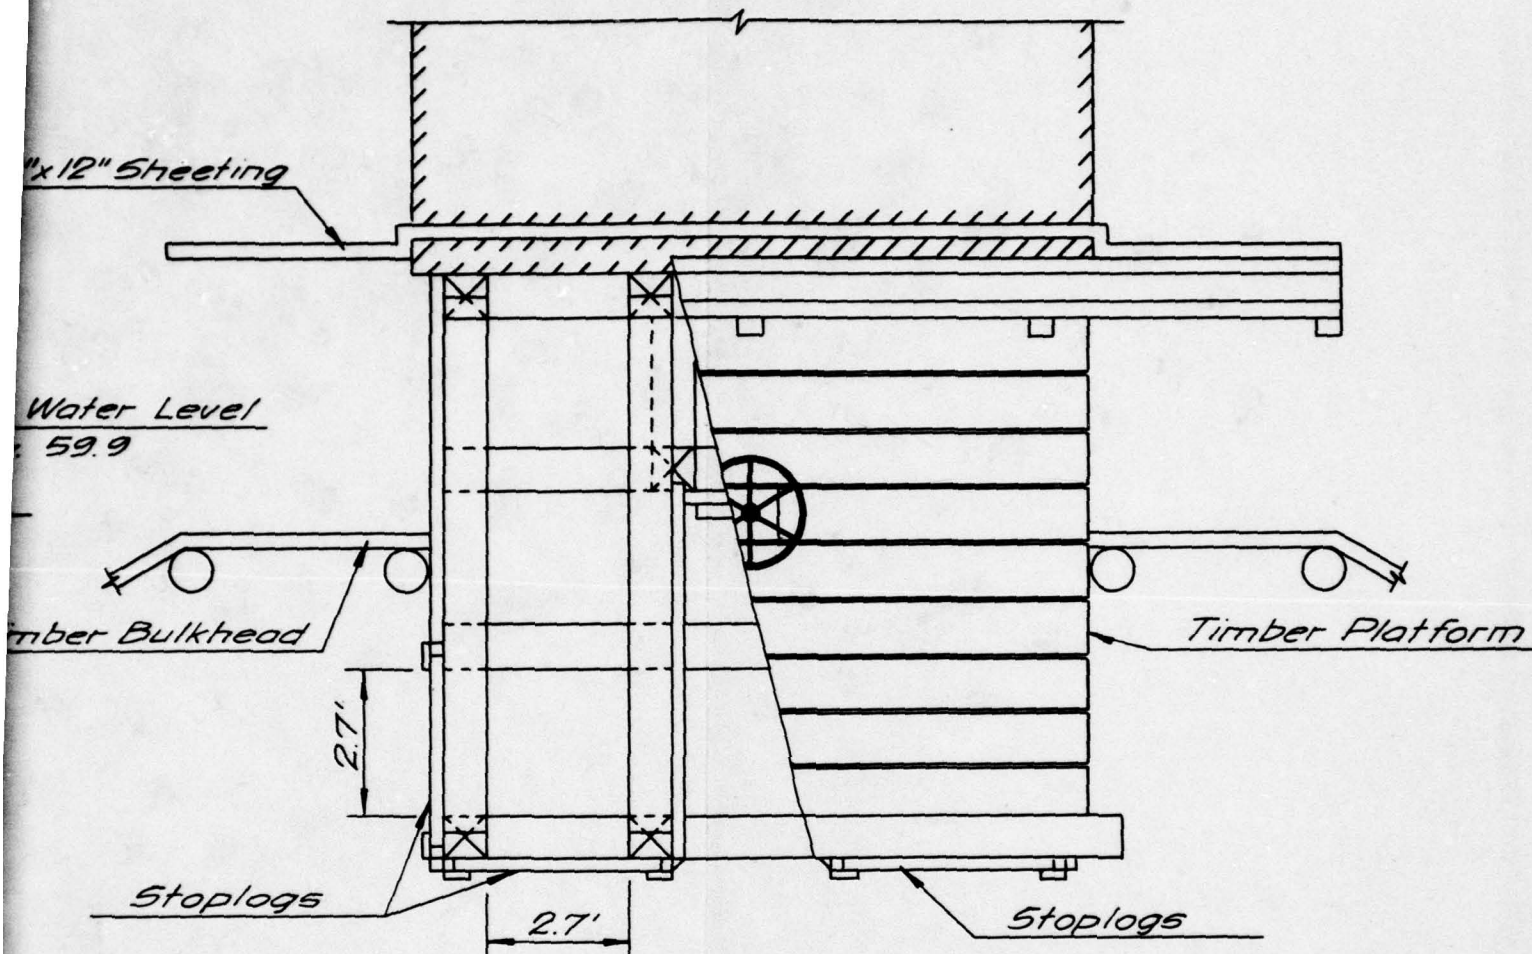
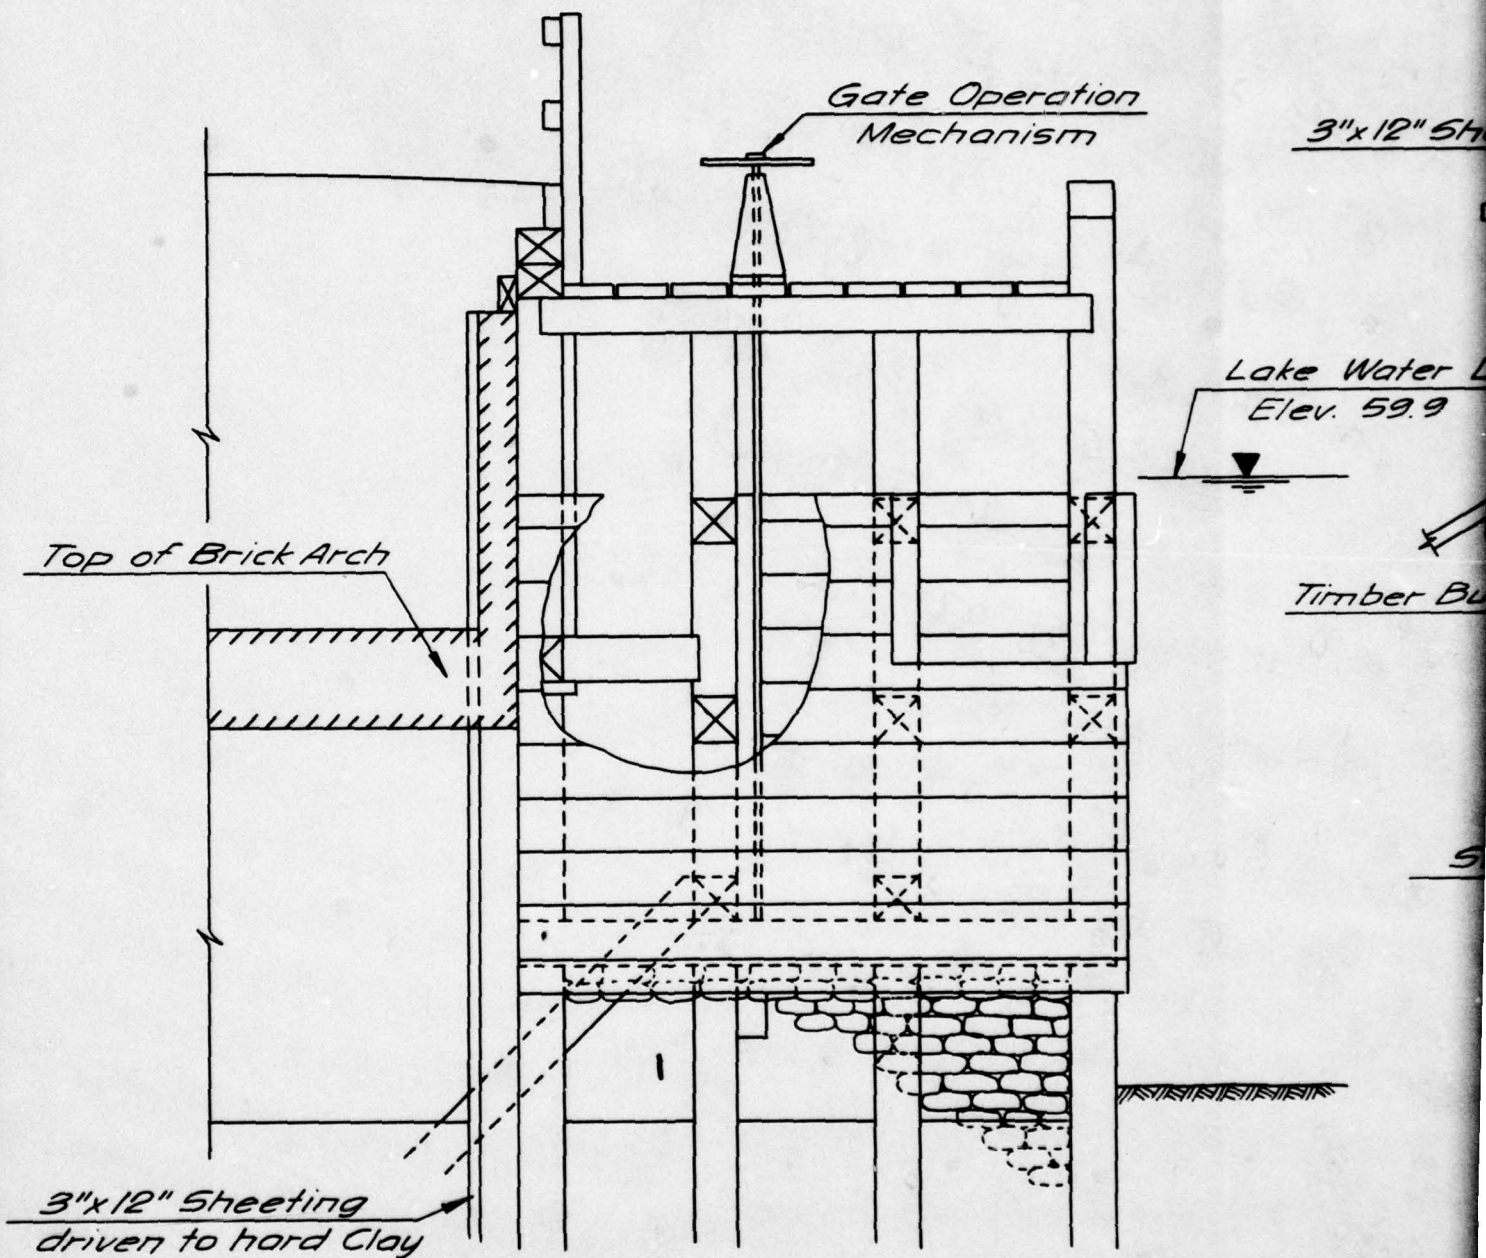
PLATE 5

The spillway consists of a timber box with a timber cover platform (See Plate 5). The lake discharges via overflow through five timber stoplog controlled openings. Three openings are located on the south face of the timber structure. The center opening is connected by a timber chamber to a manual slide gate, which discharges into the

d. Within one year from the date of approval of this report the submerged portion of the timber box spillway and the discharge culvert should be inspected closely and repaired as necessary.
